EYEBALL SPRING HANGER BOLTS

TAKE A LOOK
RIGHT NOW, DRIVERS,
TO SEE IF THE **SPRING
HANGER BOLTS** ON
YOUR M917A1 DUMP TRUCK
HAVE BEEN INSTALLED
CORRECTLY.

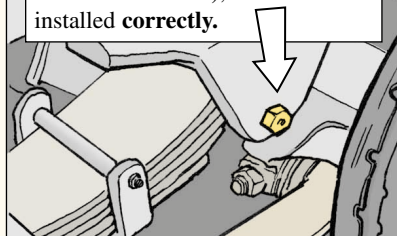
If the **bolt head** is visible on the outside of the spring hanger (you can see it without crawling underneath the truck), the bolt is installed **correctly**.

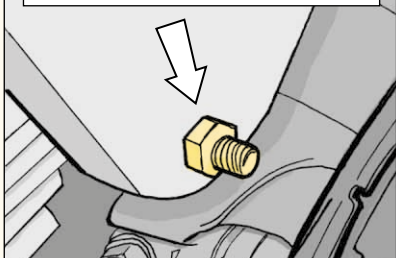
If the **threaded end** is visible on the outside of the spring hanger, the bolt is installed **incorrectly**.

Let your mechanic know if the threaded end is visible so the problem can be corrected. Let him know if there is tire damage, too.

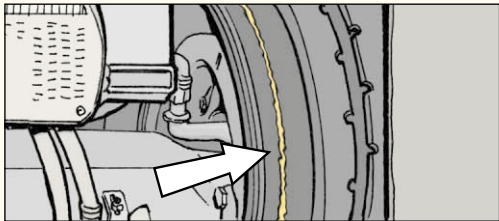
It may have already caused some tire damage because the tire rubbed against the bolt end when the truck was heavily loaded.
